DEPARTMENT OF TRANSPORTATION**DIVISION OF ENGINEERING SERVICES**

Quality Assurance and Source Inspection

Contract #: 04-0120F4Cty: SF/ALA Rte: 80 PM: 13.2/13.9File #: 1.28**WELDING INSPECTION REPORT****Resident Engineer:**Pursell, Gary**Address:** 333 Burma Road**City:** Oakland, CA 94607**Report No:** WIR-012813**Date Inspected:** 29-Mar-2010**Project Name:** SAS Superstructure**OSM Arrival Time:** 630**Prime Contractor:** American Bridge/Fluor Enterprises, a JV**OSM Departure Time:** 1500**Contractor:** American Bridge/Fluor Enterprises, a JV**Location:** Job Site**CWI Name:** Bernie Docena**CWI Present:** Yes No**Inspected CWI report:** Yes No N/A**Rod Oven in Use:** Yes No N/A**Electrode to specification:** Yes No N/A**Weld Procedures Followed:** Yes No N/A**Qualified Welders:** Yes No N/A**Verified Joint Fit-up:** Yes No N/A**Approved Drawings:** Yes No N/A**Approved WPS:** Yes No N/A**Delayed / Cancelled:** Yes No N/A**Bridge No:** 34-0006**Component:** Orthotropic Box Girders (OBG)**Summary of Items Observed:**

- 1) OBG L1E/L2E - field splice back gouging
- 2) OBG L2E/L3E - splice welding setup
- 3) Document reviewing

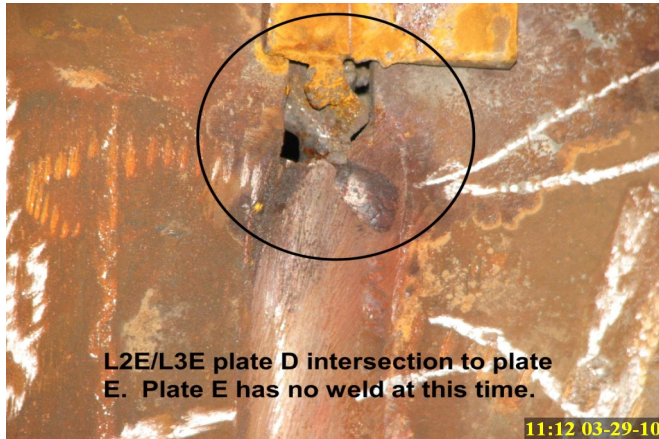
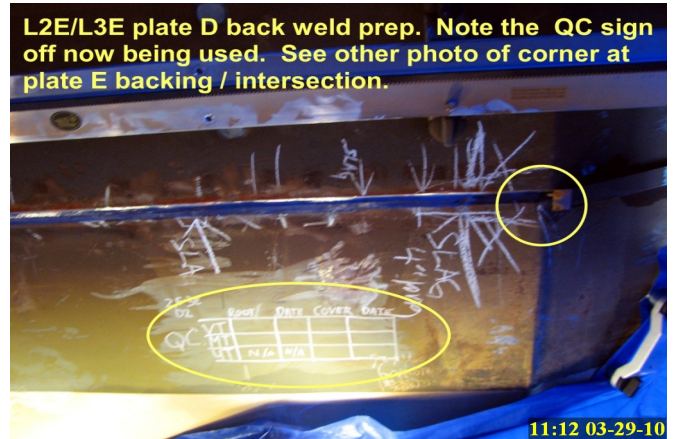
been directed to mark all weld locations as observed. The QAI observed that these markings are visible at the plate D exterior (back weld) location and that the back gouged preparation has not been accepted by QC at this time. The QAI also observed that at the corner intersection between plate D and plate E, where D has been back gouged, there is a gap. The QAI is aware that plate E splice weld has not been made yet. See the attached photos.
